Overspeed incident with disintegrated flywheel

SL2020-702/PRP
September 2020

Owners and operators of
MAN Energy Solutions Four-Stroke
Diesel Engines
Type: L23/30 and L28/32 GenSet &
Propulsion

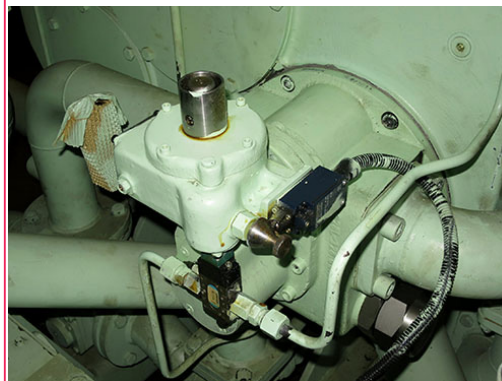
A recent incident on a license build engine was reported to MAN ES where a governor was replaced by the vessel crew. Subsequently the replaced governor failed during engine start up and the engine went into uncontrolled overspeed. After a few seconds, the flywheel disintegrated, causing severe damage. The root cause analysis of the failing governor and the subsequent disintegration of the flywheel is still ongoing. Preliminary information indicates that the replaced governor was not installed as per the makers specifications, that the safety system that should prevent uncontrolled engine overspeed did not function properly and that the material used for the failing flywheel might not have been within our specifications.

MAN ES warns that an uncontrolled engine overspeed can potentially result in damaged valve gear, piston, connecting rod or flywheel causing engine failure and may potentially even result in bodily injury and/or fatal casualties.

MAN ES request that installation and maintenance of the governor is done in accordance with Makers instruction. In case of doubt, do not hesitate to contact the respective engine builder, MAN ES and/or the Governor maker directly before working on the governor as a wrong installation might lead to an uncontrolled overspeed.

Engine overspeed tests must be done according to the classification society rules and the Instruction Manual to ensure that the safety system functions correctly, cf. also our Service Letter [SL2015-600](#) from April 2015.

When performing such mandatory overspeed test, please follow the instructions M5090105-12 (L23/30H), M6090105-03H (L28/32H), D10403-02-L2330AK, D10403-02-L2832A, D124A1-03-L2330AK, D124A1-01-L2832A.
