Fuel Injection Valve Condition

SL2016-628/KEL
October 2016

Owners and operators of
MAN four-stroke diesel engines.
Type: L16/24, L23/30H, L21/31, L27/38,
L28/32H, V28/32S

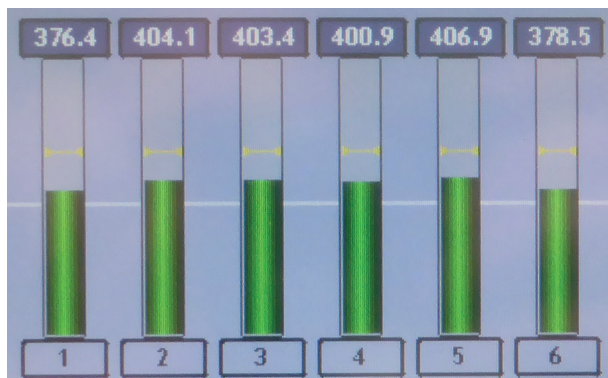
Not a criterion for remove any fuel injection valves for pressure testing, adjustments or overhaul.
Fuel valves should remain in engine unless other indications dictate so.

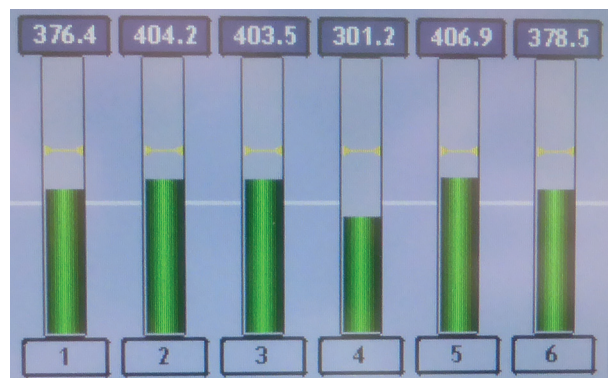
Low exhaust gas temperature at cyl. no. 4.
 If the temperature decrease is related to the fuel injection valve the cause is most likely sticking needle in fuel nozzle.
Fuel injection valve should be removed for checking.

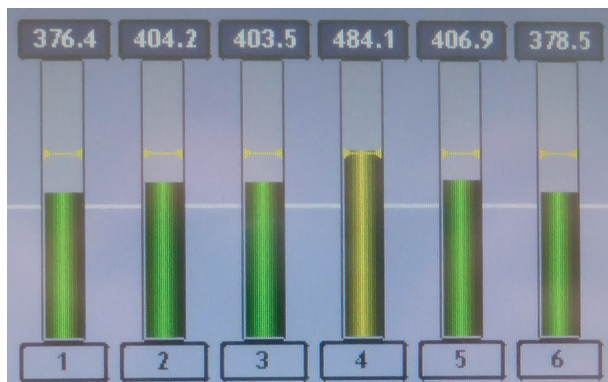
High exhaust gas temperature at cyl. no. 4.
 If the temperature increase is related to the fuel injection valve the cause is most likely leaking or worn fuel nozzle.
Fuel injection valve should be removed for checking.

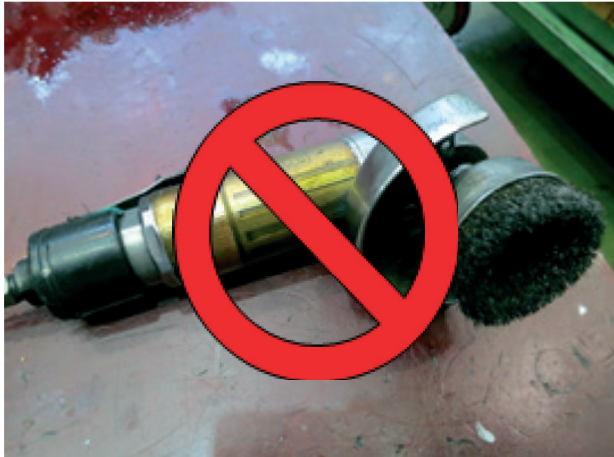
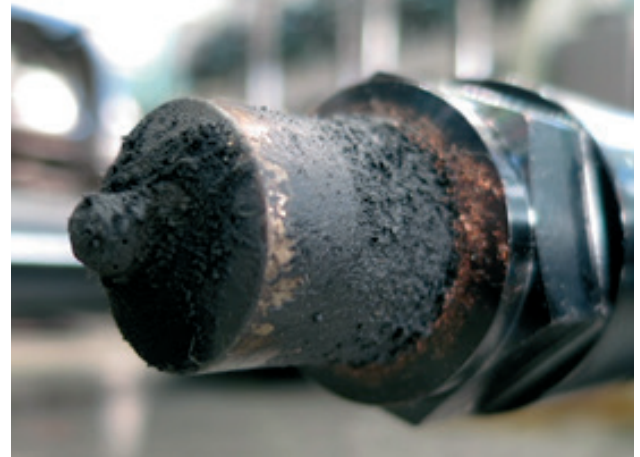
Steel brush including rotating steel brush will destroy the nozzle spray holes and a new nozzle element is required.

Correct cleaning procedure of the nozzle is necessary to ensure proper atomisation of the fuel in the combustion chamber

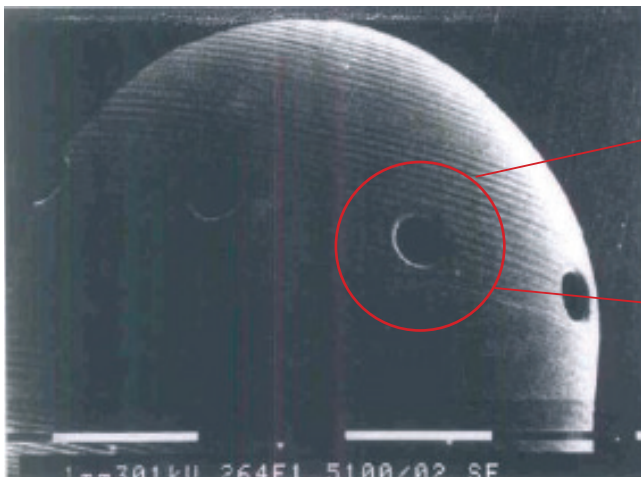
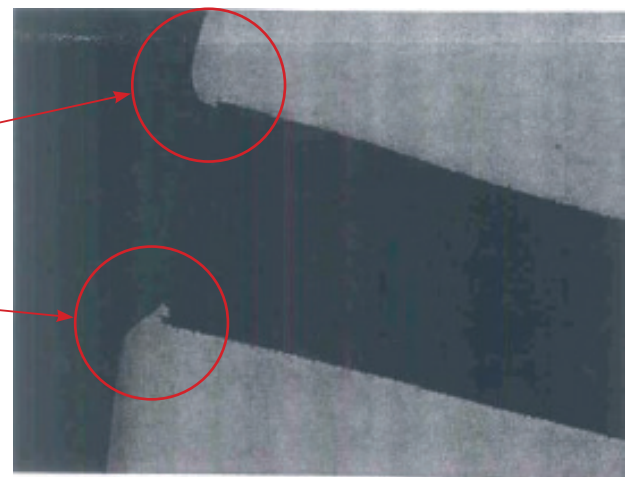
Example of a nozzle tip cleaned by a rotating steel brush causing edges in the nozzle bores which destroy the atomisation. Complete and clean combustion is a function of fuel atomisation.

Carbon deposit accumulation around the fuel injection nozzle can be cleaned with a nylon sponge and diesel oil as this will not harm the nozzle holes

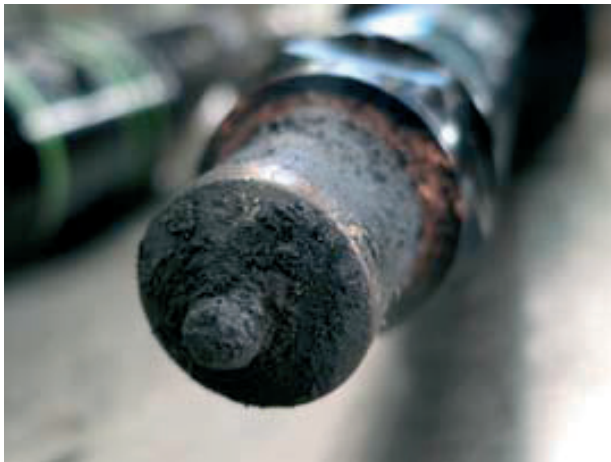
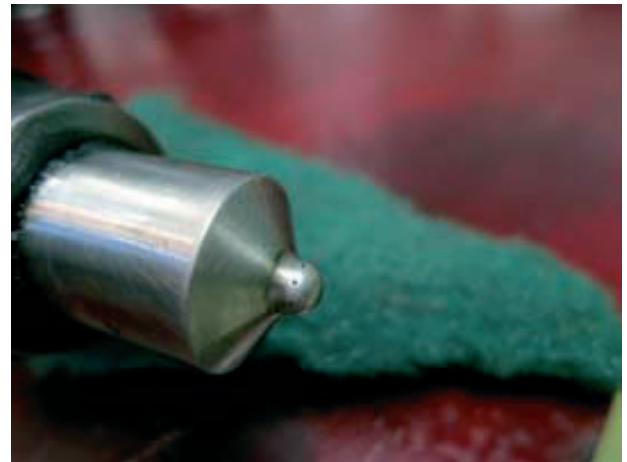
Nozzle condition before cleaning & after cleaning with a nylon sponge.
